Historic Preservation Design Review

HP-10-10, 13 N. Main St. (City)

Request: Design review approval for proposed façade restoration/renovations to include: new storefront, restoration of damaged molding using precast concrete; reopening closed window openings and installing new windows, and repairing existing precast inlay to match existing.

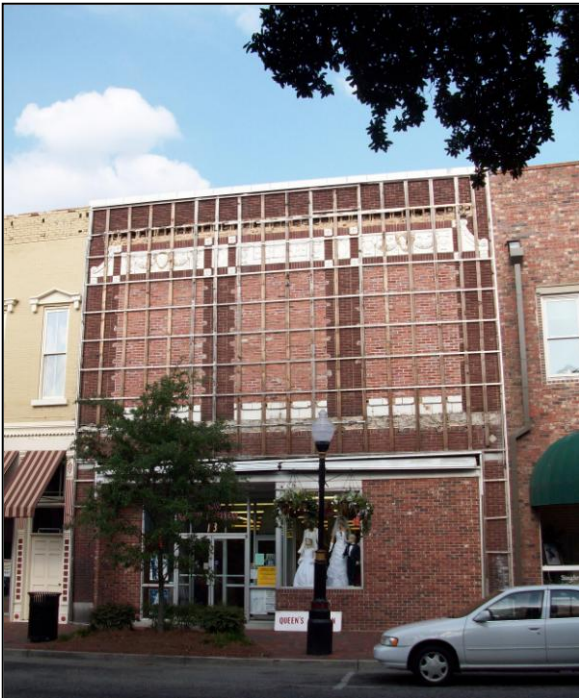
The building is located on the east side of N. Main St. between New York Hi-Style and Imports, Ltd. The photograph to the left shows the existing front façade. Prior to submission of this request, the metal veneer that was placed on the front of the building in the 1970s was removed to determine the extent of façade damage and to develop restoration plans.

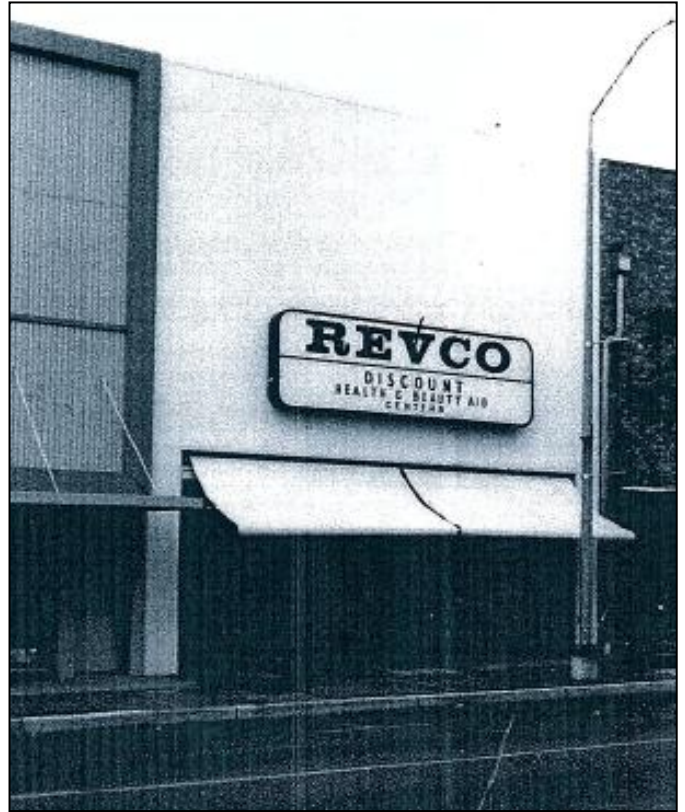
constructed circa 1887 as confirmed on Sanborn Maps. The building is an L-shape plan consisting of two floors with the addition of one floor inside the L, making the existing floor plan rectangular in nature. The building is divided vertically into two nearly equal by separate facades on Main St. As shown in the photograph to the right, at the time of the Survey, the façade at 13 N. Main St. was obscured by an aluminum veneer and altered storefront. This alteration did not allow for full analysis of the integrity of the façade or condition of any windows on the structure.

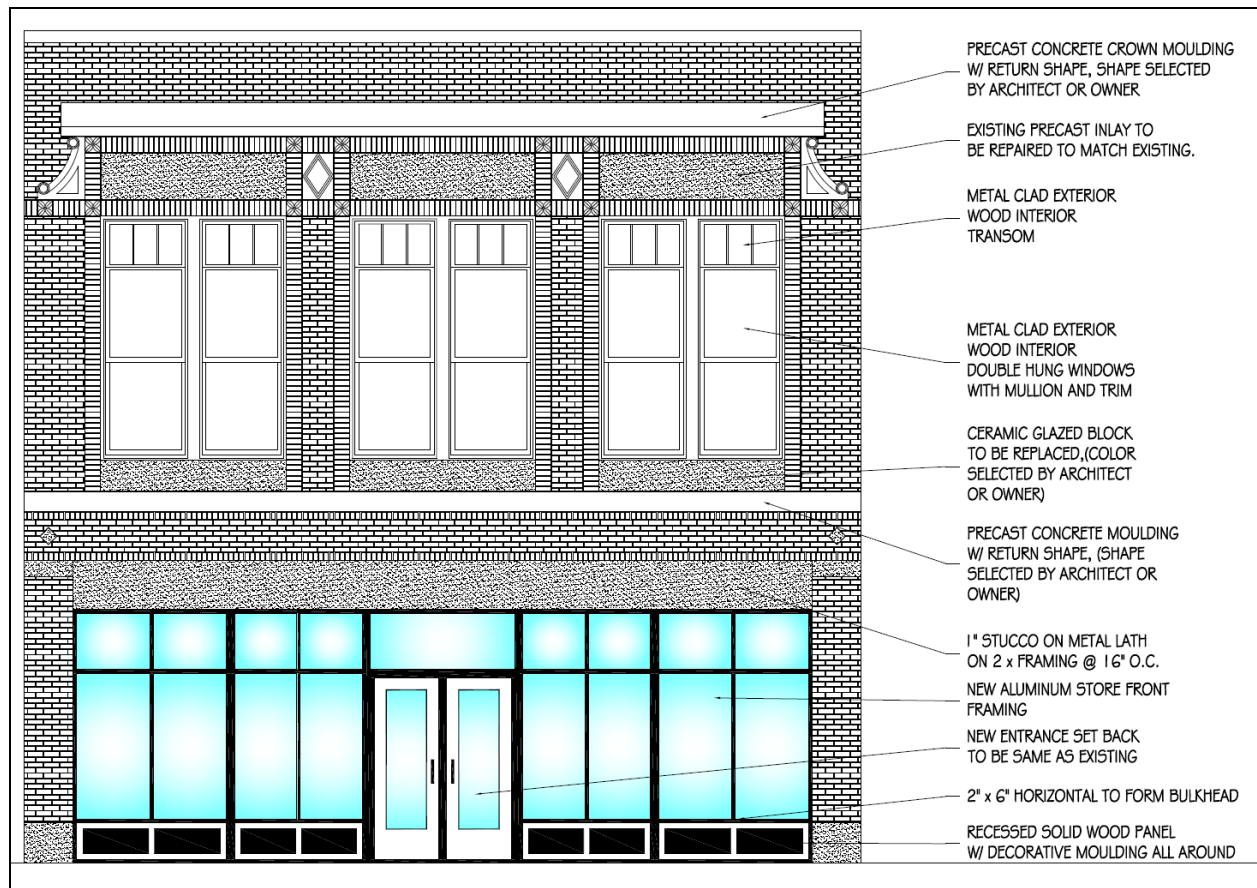
The proposal submitted by the project architect is as follows:

There is no original transom remaining. The new storefront will have transoms as shown in the elevation on page 3 of this report.

The roof cornice has been destroyed. As shown in the proposal on page 3 of this report, the new roof cornice referred to as crown molding in the elevation, will be based off of the remaining ghosting of the building.

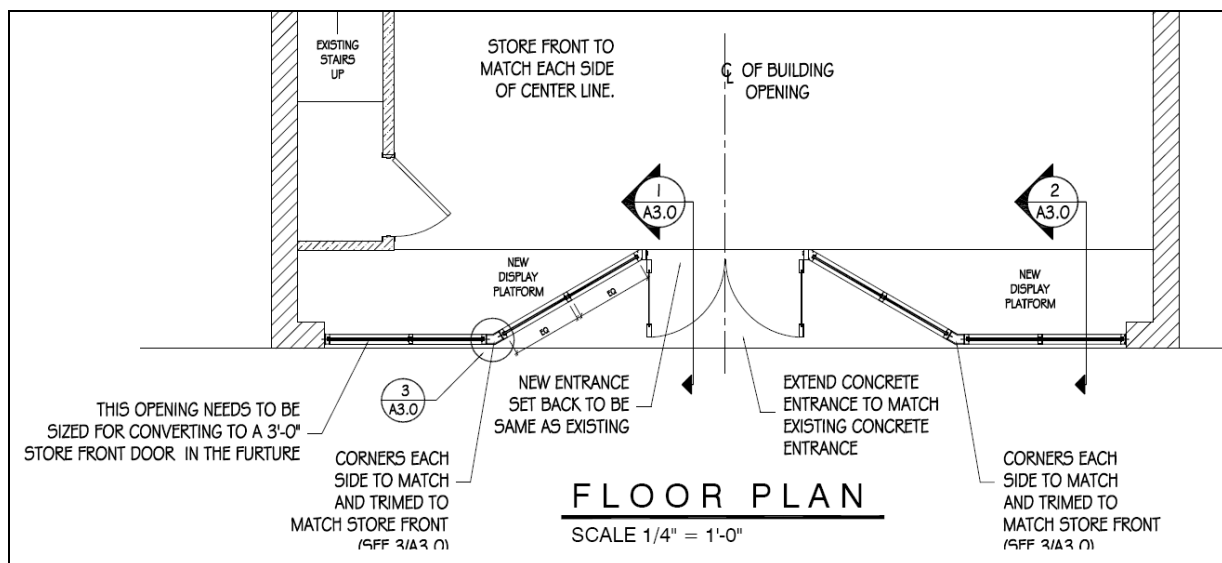
As shown in the following graphic, the entrance is to be recessed with concrete extended to match the existing concrete entrance.

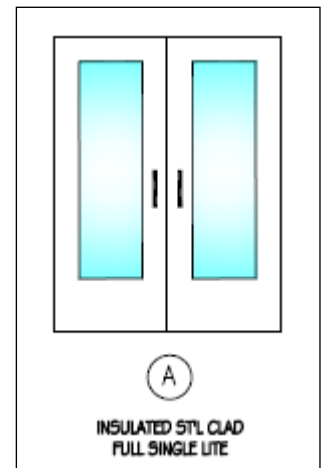
The building has no original doors. The proposed replacement doors that are part of the storefront will be insulated steel clad doors that can be painted as shown to the right.
